Check Cracking

“Check Cracks” or “Shrinkage Cracks”

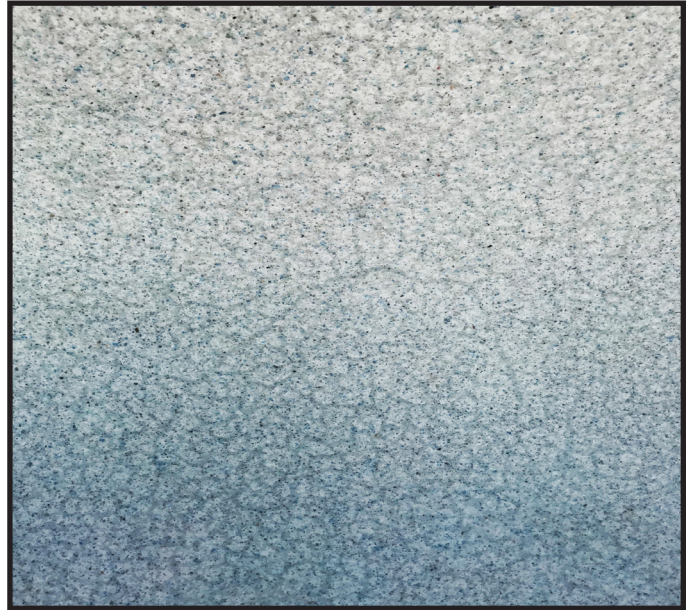
“Check Cracks” or “Shrinkage Cracks” are inherent to some degree in all cement mortar mixes, and are not considered a material defect.

Accelerated drying causes these types of cracks, which can be attributed to weather conditions such as wind, temperature and humidity. According to the National Spa & Pool Institute Technology Performance Guidelines, “this is a normal occurrence and is not considered a deficiency”.

Commonly, “Check Cracks” or “Shrinkage Cracks” are minor surface cracks. It is virtually impossible, without draining the pool’s water and cutting out a sample of the plaster, to determine whether or not this is a structural crack in the concrete shell or just a normal shrinkage crack.

Structural cracks in the concrete shell may create cracks in the plaster that are beyond the control of the plasterer. Plaster is not designed to provide structural strength.

To repair minor “Check Cracks” or “Shrinkage Cracks” in the plaster, fill the pool with water and allow plaster to be submerged completely. In certain instances the minor voids due to the cracking will expand and become difficult to detect.

In some slight cases, polishing the pools finish may also reduce the visibility of these cracks. In a more severe case, using a concrete saw, make cuts approximately $\frac{3}{4}$ ” deep on either side of the crack. Keep the saw cuts as straight as possible while following the crack. Remove the plaster between the saw cuts carefully. Roughen the now exposed surface and fill this section with matching Diamond Brite pool finish.
